**The Tankship Tromedy**

**The Impending Disasters in  
Tankers**

Jack Devanney  
Sisyphus Beach  
Tavernier, Florida

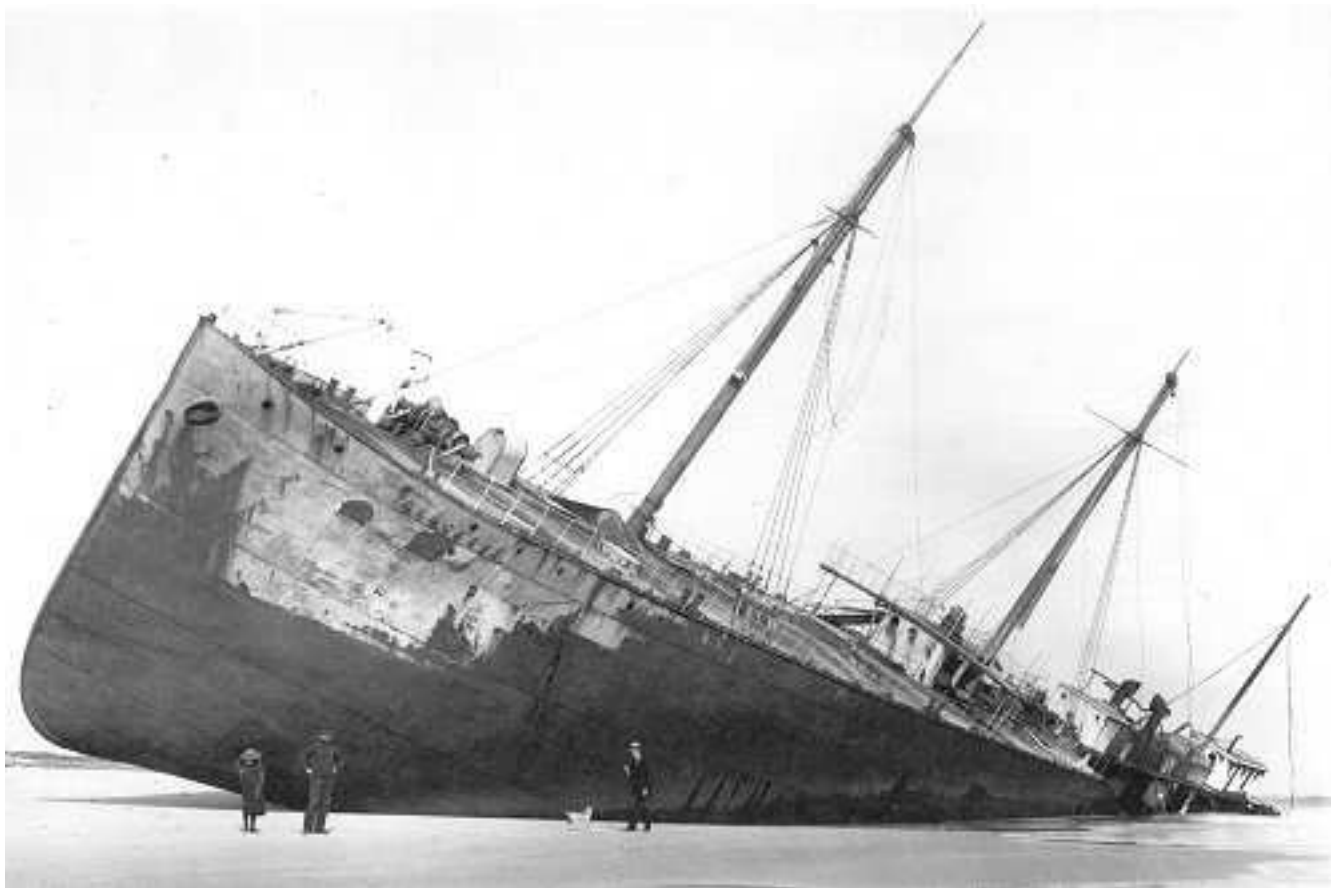
Figure 2.1: Glückauf stranded on Fire Island, 1893. No modern tanker would still be intact in this situation.  
Source: Long Island Maritime Museum.

<sup>7</sup> All normal cargo ships have double bottoms. On the Glückauf this was eliminated to avoid explosions resulting from cargo leaking into the double bottom space.

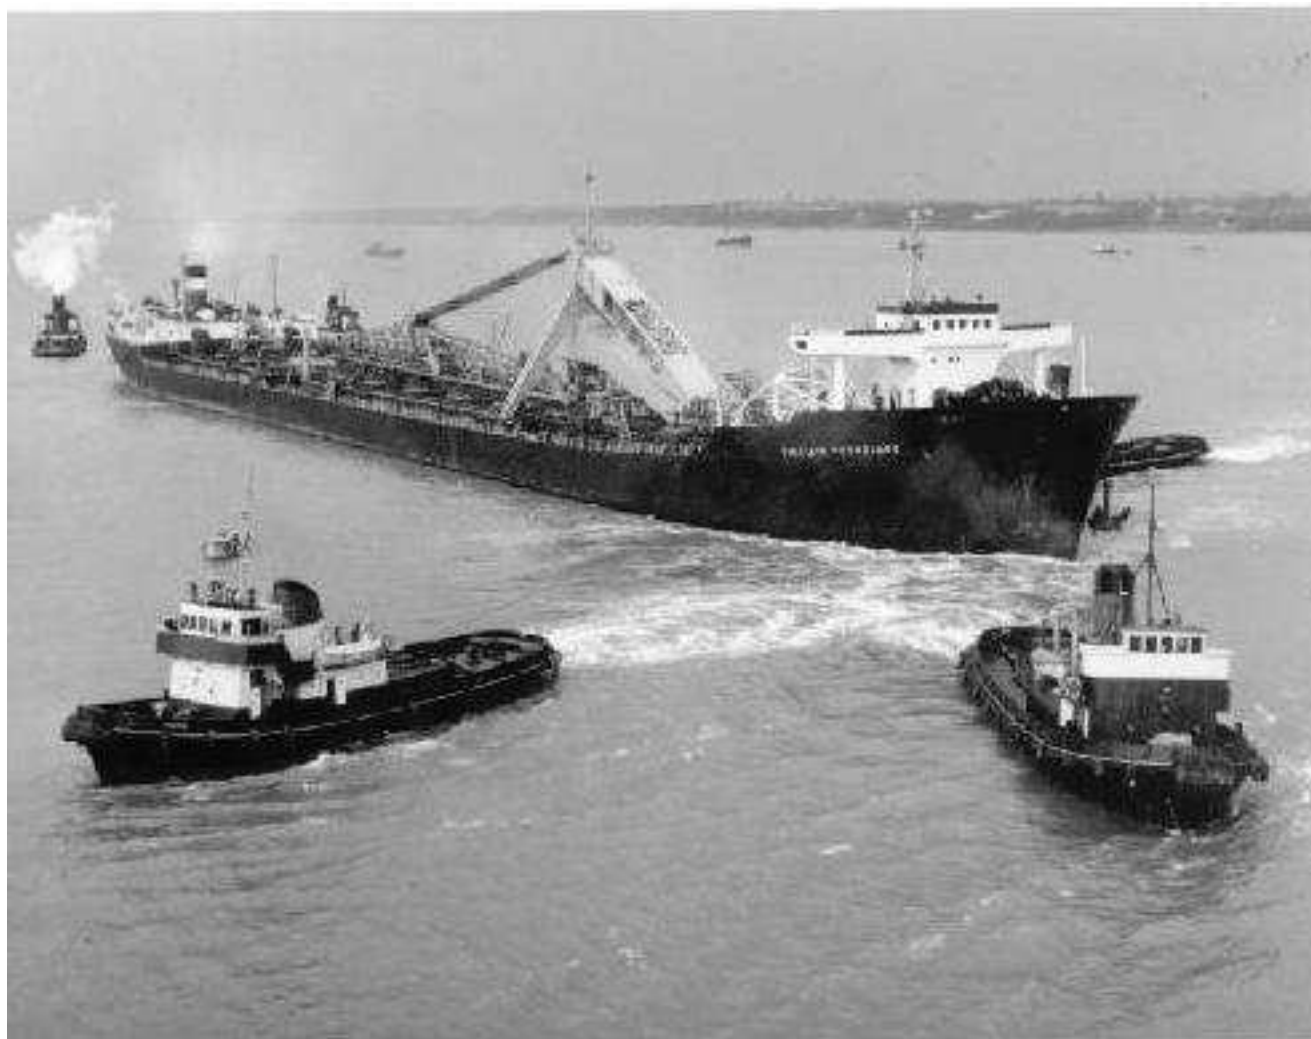
Figure 2.2: Sinclair Petrolore: Self-Unloading Ore-Oil Carrier. Source: [www.solentwaters.co.uk](http://www.solentwaters.co.uk)

<sup>13</sup> The SINCLAIR PETROLORE, Figure 2.2, was truly unique; not only the biggest ship in the world but a self-unloading ore/oiler. The world has never seen anything like her before or since. In 1960, she exploded off Brazil spilling 60 million liters. This was the largest oil spill ever at the time by at least a factor of two. Most likely cause was cargo leaking into the double bottom.

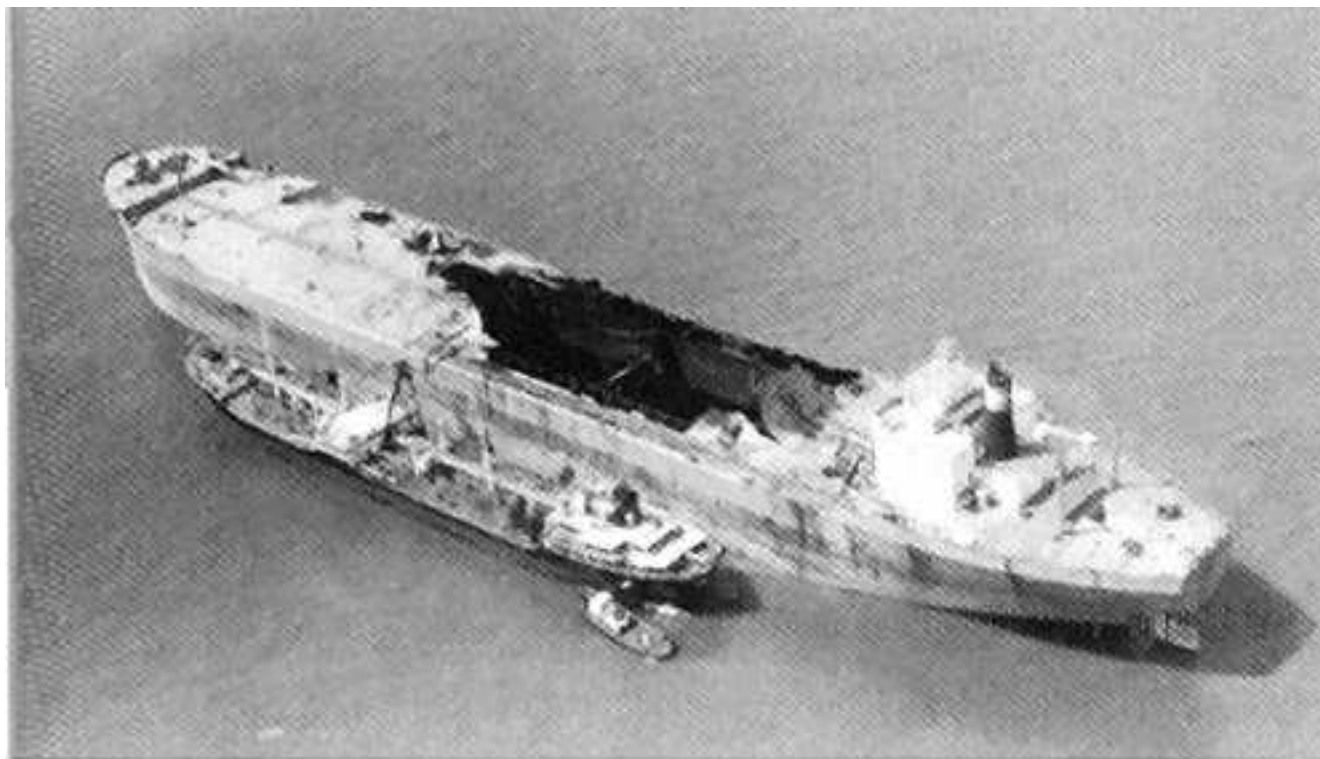
Figure 2.5: Kong Haakon deck after tank cleaning explosion. Obvious similarity to Mactra. Source: Auke Visser, [supertankers.topcities.com](http://supertankers.topcities.com)

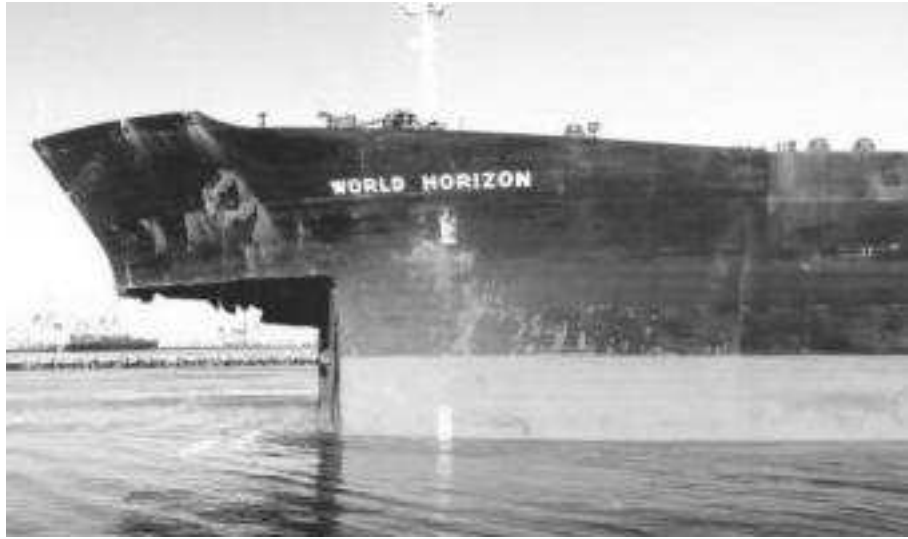
Figure 2.8: World Horizon after “freak wave” removed forepeak tank. This wave was able to excise only the forepeak tank with almost surgical precision. The true cause was that this segregated ballast tank was very badly corroded. The surrounding spaces were not. Spill was about 850 kiloliters. Source: University of Capetown.

We also started seeing big failures in the forepeak tank, the other segregated ballast tank in a pre-Marpol tanker. In several of these cases, the forepeak tank simply fell off. Examples include the WORLD HORIZON, Figure 2.8, the GALP FUNCHAL, the TOCHAL, Figure 2.9 and the ENERGY ENDURANCE

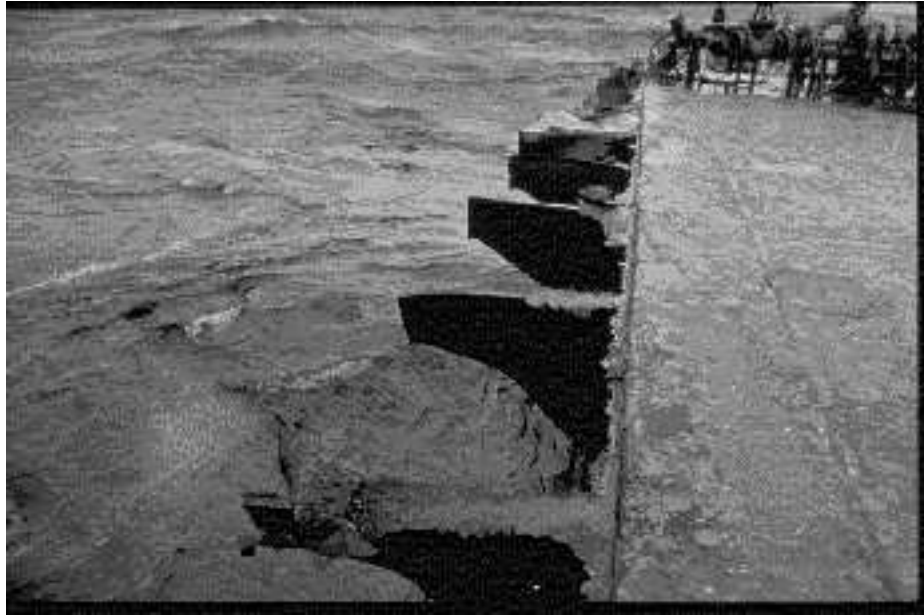
Figure 2.10: Kirki sans forepeak tank. Once again fairly sharp cut at aft end of forepeak tank. Deck had become wafer thin forward of this point. Source: Australian Maritime Safety Authority.

The KIRKI is the best documented example of a vanishing forepeak tank. In 1991, this ship ran into bad weather off Western Australia, while loaded with a volatile crude. The forepeak ballast tank was horribly corroded. The hull structure failed on deck at the bulkhead between the forepeak tank and the forwardmost cargo tanks. The combination of hydrocarbon vapor escaping from the cargo tanks and the loose steel banging around started a fire, which was then put out by the sea. This process was repeated several times until the whole Forepeak tank just fell off, Figure 2.10

in order. She was nicely painted. Yet when the Australians inspected this ship, they found massive corrosion not only in what was left of the forepeak, Figure 2.10, but in the aft segregated ballast tanks as well.<sup>43</sup> They found rust camouflaged with canvas. And they found the ship's safety gear, and some of machinery including the boiler safety valves in horrible condition. The Australians were at a loss to explain how the ship's Classification Society could have missed all this. Germanischer Lloyd for its part blamed "poor cooperation" on the part of the owner, Thenamaris.<sup>44</sup> In fact, owner and Class had developed the normal close working relationship.

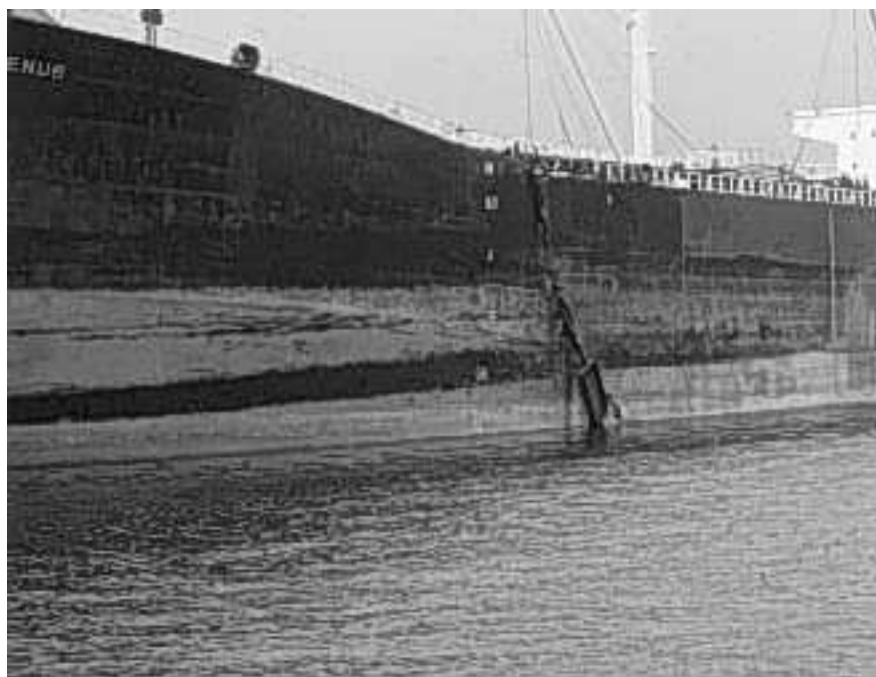
Figure 3.3: Alvenus buckled after grounding. Source: R. Hann.

<sup>76</sup> The ALVENUS is an example of a grounding in which we can be confident a double bottom would not have helped. The ALVENUS hit the sea bottom in a manner that the bow was pushed up. The main deck split open forward with the rupture extending down to the waterline on either side. See Figures 3.3 and 3.4. The ship's single bottom was never penetrated. Paik has shown that modern double hulls are very weak when it come to deck buckling.[75]

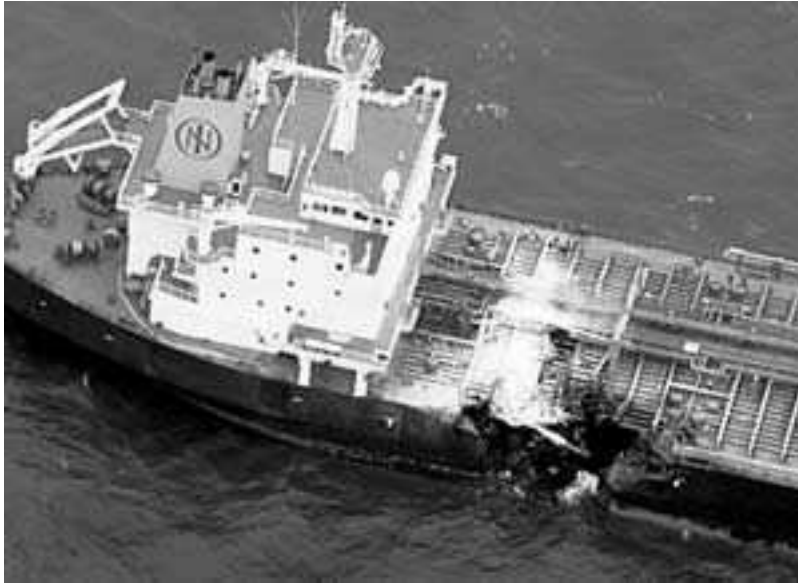
Figure 3.5: Helo view of double hull Baltic Carrier. Source: DR.

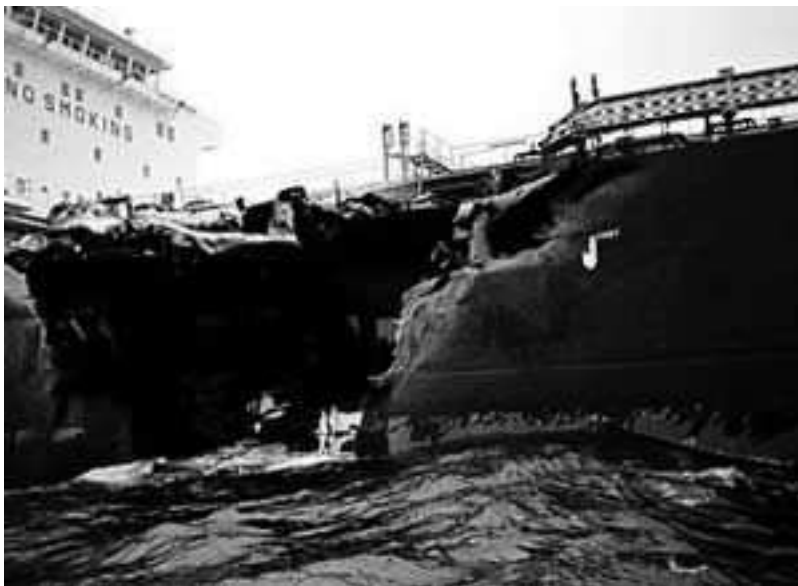
Figure 3.6: Close up view of Baltic Carrier penetration. Source: DR.

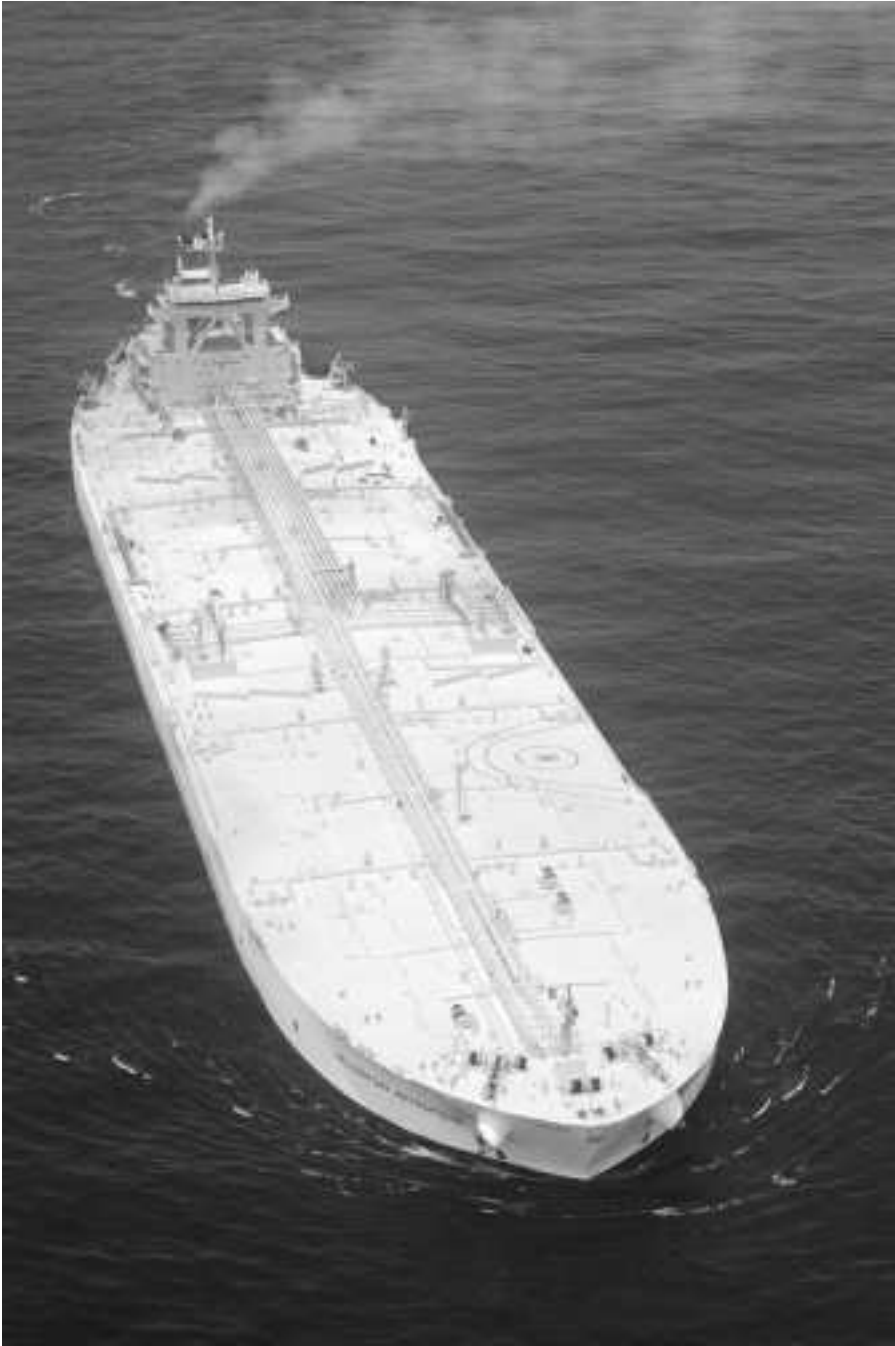
Figure 4.1: The All-White Tanker: Clean and Cool.

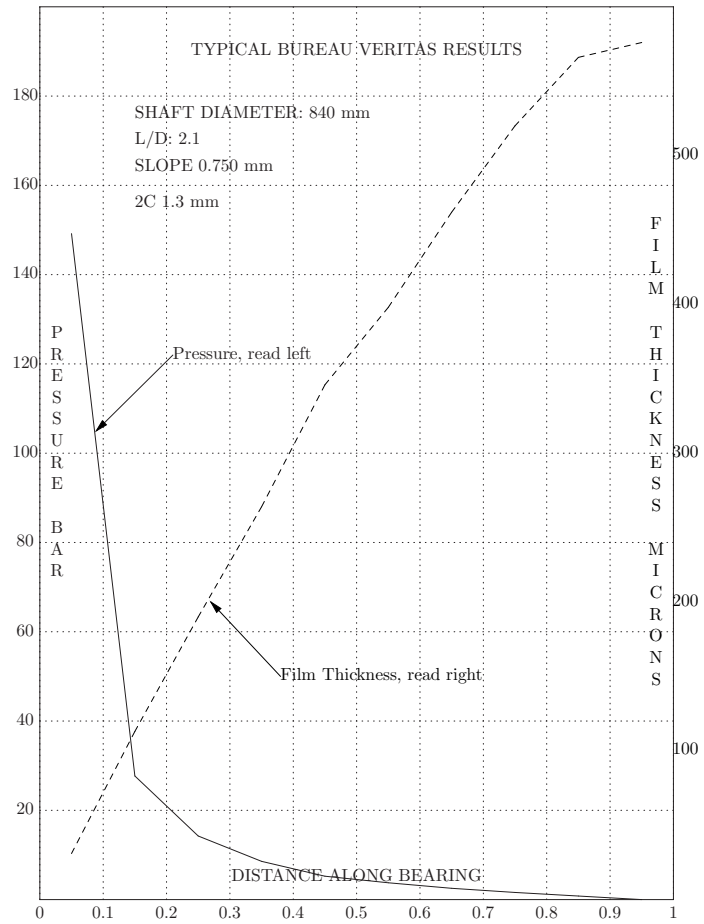
Figure 5.1: Sterntube bearing pressure and oil film thickness

FIGURE 13.1 AFT STERN TUBE BEARING PRESSURE AND FILM THICKNESS

There are no Class restrictions on shaft bending within the bearing. However, there is one Class that has the capability to study at least a part of this problem. Bureau Veritas (BV) has a program which has the ability to model bending within the bearing and determine the resulting pressure distribution and oil film thicknesses within the bearing. Figure 5.1 shows a typical result. Figure 5.1 is based on an alignment that was acceptable to Class on the grounds that the misalignment at the aft end of the bearing was small ( $1.0e-4$  radians) and the nominal pressure (bearing load versus overall bearing area) was a reasonably conservative 6.3 bar, well below the Class limit of 9.0 bar. But what counts is the distribution of the pressure within the bearing and the standard Class approved method simply cannot address that issue. In this case, the BV results show the pressure on the aft 10% of the bearing averages 140 bar, well over BV's recommended (and none too conservative) maximum of 100 bar. At this pressure, the lubricating film thickness is a miniscule 31 microns.

Figure 5.1 is the reason why the composite bearings failed immediately while the white metal bearings have taken longer. There is only one area where white metal bearings are better than composite; but in that area they are far better. That area is heat conductivity. The conductivity of white metal is over 30 times higher than that of the composite material. The composite bearing relies on the lubricating fluid to conduct away the 7.5 KW of heat generated in a VLCC stern tube bearing. But most of that heat is generated in the high pressure portion of the bearing where the film thickness is much too thin to do the job. The composite bearing burns out almost immediately. White metal has a great deal more ability to conduct

the heat away itself, so there is no immediate burn out despite the thin film thickness. But that doesn't change the fact that the pressures are very high, in fact far above the yield point of the white metal. Rapid wear down will occur, and premature failure is inevitable. We will see a lot of VLCC's dead in the water due to bearing failures. The only real question is: how many will drift ashore?<sup>34</sup>

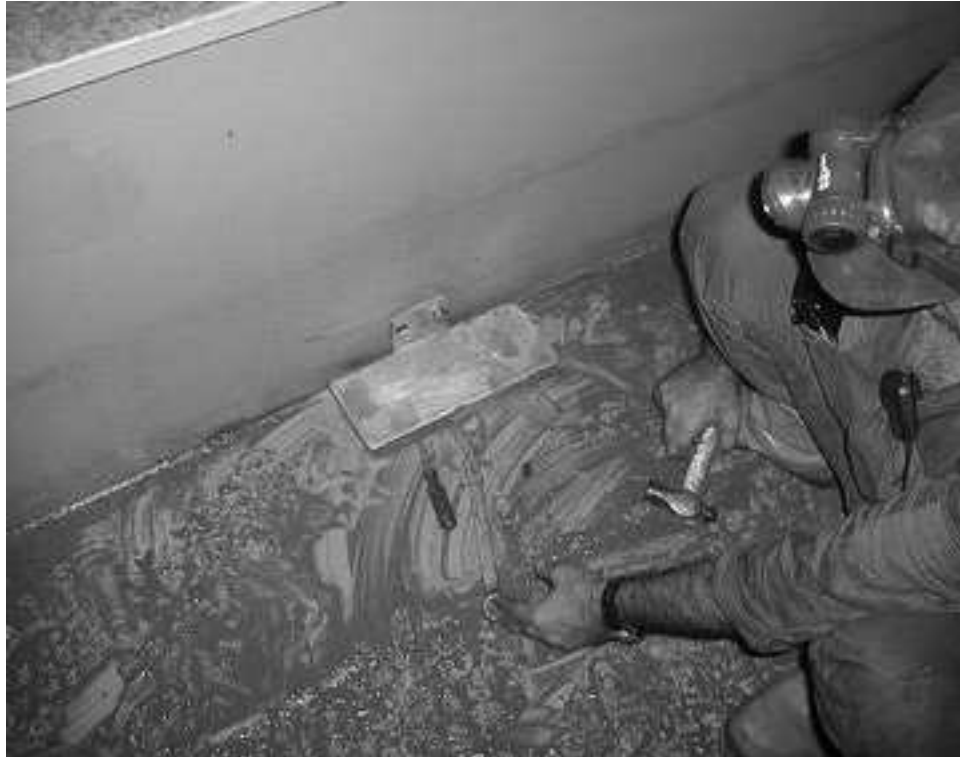
Figure A.1: Installation of Tsevas Pitguard

The normal anodes can do nothing about this layer of water, since they will not be immersed. To protect the bottom of the ballast tank we need a special kind of anode called a *pitguard*. Figure A.1 shows the system Hellespont uses. The key is to get the bottom of the pitguard right on the

bottom of the tank, so that at least some of the zinc is always immersed.

The solution is to have the yard cut only the mounting holes in the bottom stiffener webs (without edge treatment). Plugs are placed in the holes to protect the hole inner surface from the coating. After delivery, we have our own crew actually install the pitguards, pulling the plugs, making sure the hole surface is clean, expanding a soft stainless steel sleeve against the interior of the hole and then bolting in the pitguards to insure good electrical contact.<sup>27</sup> On the V-Plus, Hellespont put one 12 kg in each flat bottom bay. This was probably overkill. One in each aft bay plus sort of checkerboard pattern elsewhere would have been plenty. But it is important to protect the ballast tank flat bottom. The flat bottom, usually covered with some muddy water, is hard to inspect and the coating hard to repair. The flat bottom tends to get damaged during valve/piping work. It is subject to coating erosion near the strums. Unless protected, any coating defect in the flat bottom quickly turns into a major pit. Proper pitguards are necessary.

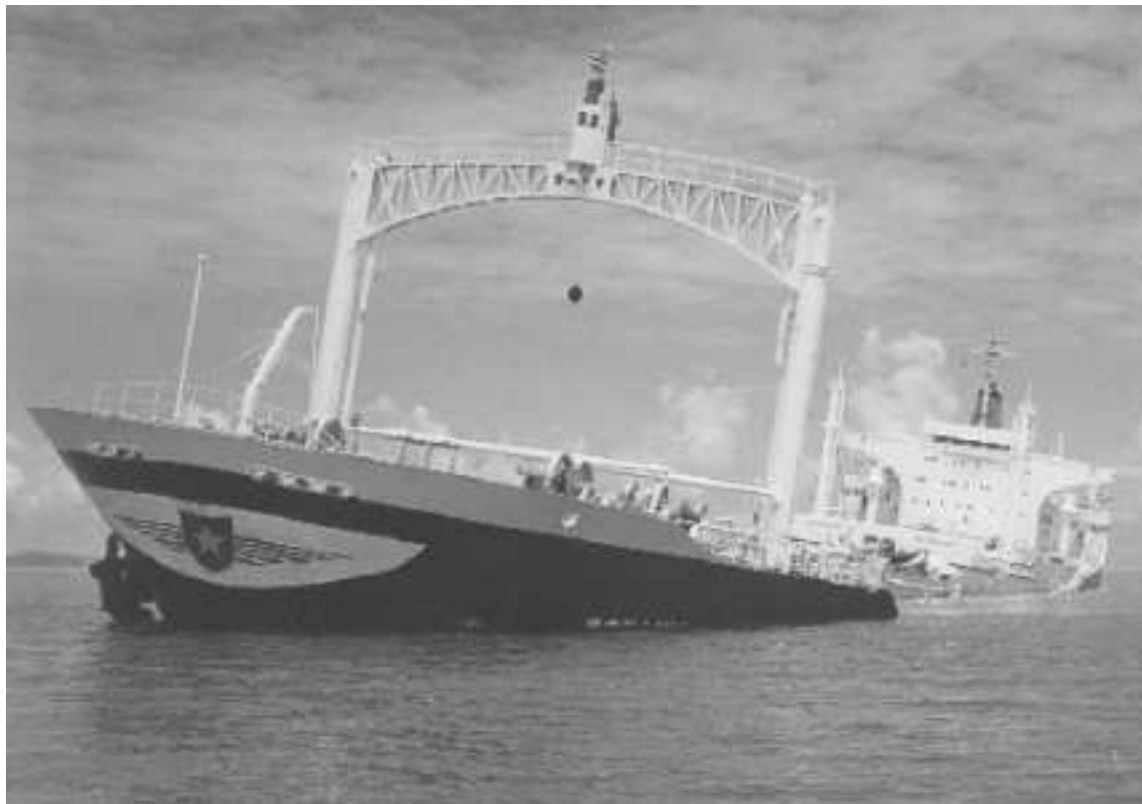
Figure C.6: Oceanic Grandeur after flooding. Hull is under extreme sagging moment but survived. No new tanker would. Note the extremely strong kingposts and the rare forward crowsnest, signs of an unusually well-sped ship. Source: Australian Maritime Safety Authority.
